Operation and Maintenance experience of Sodium Leak Detector in Monju

Keitaro MUTO^{1,*}, Daisuke HAMANO¹, Mamoru KAWABATA¹, Yasuhiro TABAKOYA¹ and Chisato YANAI¹

¹Japan Atomic Energy Agency (Monju), 2-1, Shiraki Tsuruga-shi, Fukui pref, 919-1279, Japan

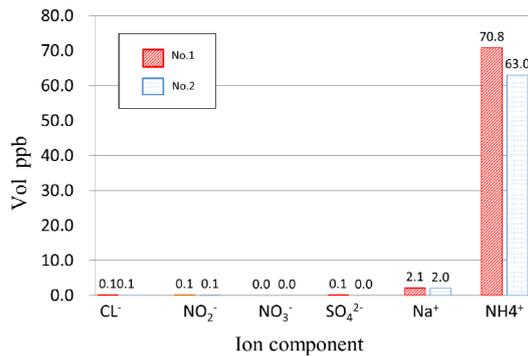
Fig. 4 Analysis of SID sampling gas by ion chromatography (pure water)

We analyzed the SID sampling gas (sample No. 1, No. 2) to identify the cause of the increase in the ion current values. The sampled gas was dissolved in pure water or hydrogen peroxide solution and analyzed to measure impurities concentration by ion chromatography. We found that the gas included chlorine, NH₃, NO_x and SO_x, which is shown Fig. 4, 5.

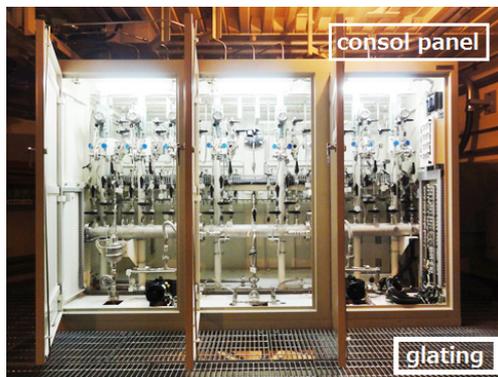
Fig. 6 SID console panel

As a result of the investigation, the on-site console panel was installed on grating, the pressure variation inside the on-site console panel was generated by opening and closing the door, and the structure was such that the air entered and exited from the grating bottom shown in Fig. 6.

It was suspected that the wind generated by the entrance and exit of this air came into contact with the surface of the coaxial cable and affected the coaxial cable for instance the air stream generates static electricity (electric charge) on the surface of the coaxial cable due to the friction between the air and the sheath (skin), so the weak current flows to the signal path. Static electricity caused by wind
