## Evaluation of Wall Thinning of the Steel Piping after Long Term Operation at Fugen Power Station

### ABSTRACT

Wall thinning of serviced carbon steel piping of the secondary cooling system after long term operation of Advanced Thermal prototype Reactor (ATR) Fugen power station has been investigated as a series of evaluation of validity and availability of utilization of serviced materials on research projects focused on aging management.

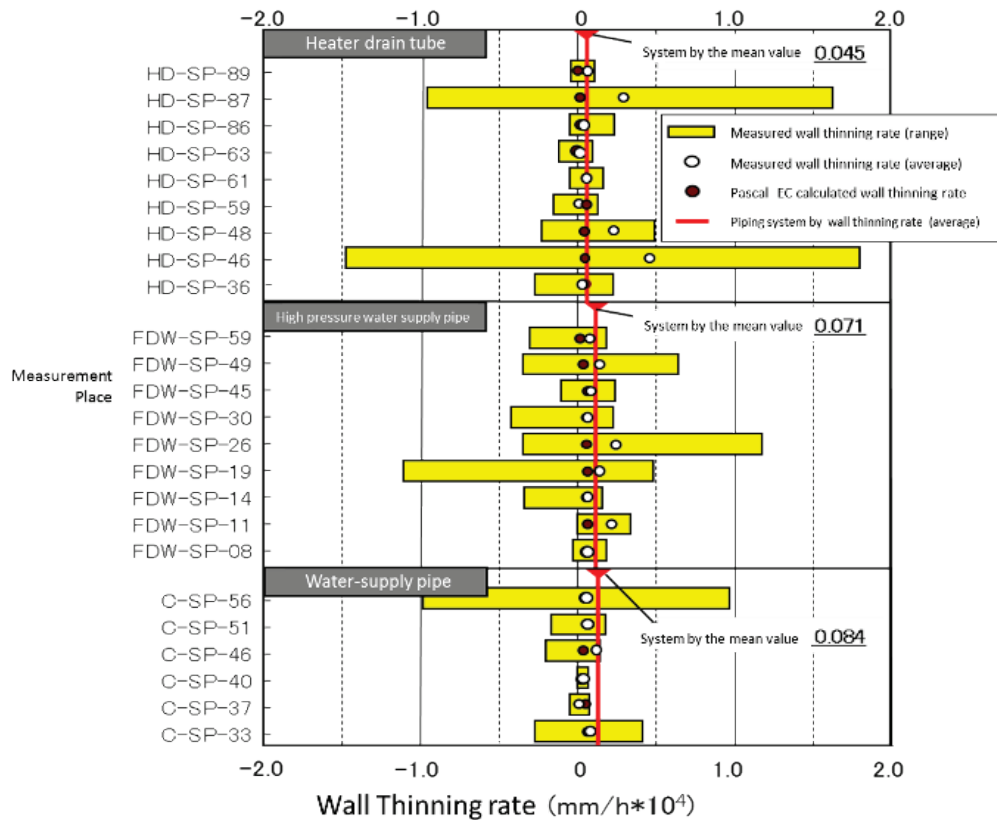
**Fig.2 Comparison of wall thinning rate between measured and predicted.**

- ① Total mean value of the thinning rates of the entire 148 measurement targets, namely, about 28,000 measurement points investigated is less than 0.1 mm per 10,000 hour, which is less than one-fifth of the one caused by the flow accelerated corrosion (FAC), 0.5 to 1.0 mm per 10,000 hour.

- ② Although the independent value of the thinning rates of the measurement points varies a lot, the mean value of the thinning rates of the each piping system is equal to the total mean value i.e. less than 0.1 mm per 10,000 hour.

- ③ The measurement points having significant variation of the thinning rates show a tendency to alter in between positive to negative value widely.
- ④ Predicted thinning rate of each measurement target, calculated by a wall thinning analysis code, PASCAL-EC, shows a little smaller value than the total mean value.

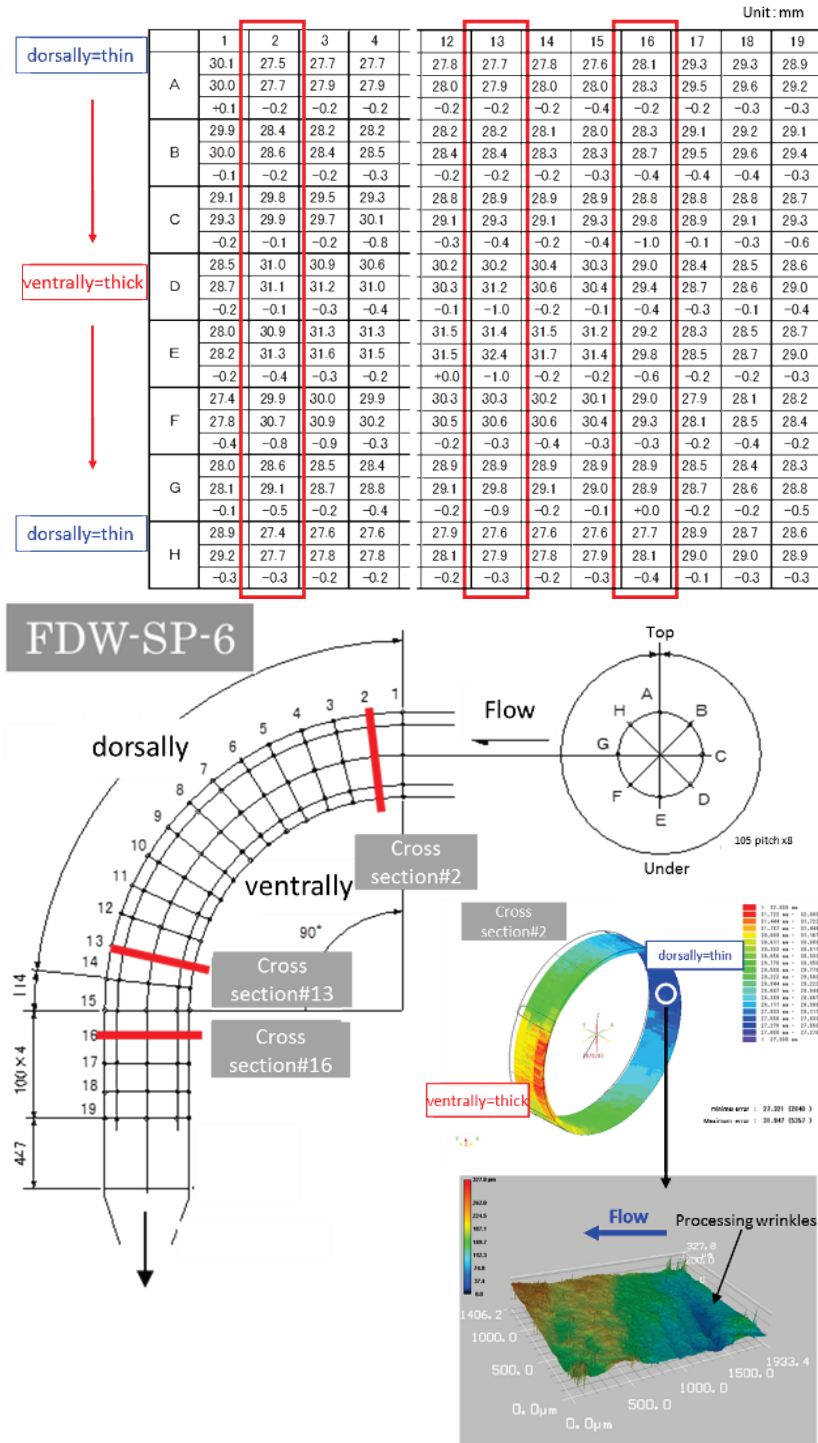
Fig.4 An example of the results of the detailed investigation.

Fig. 4 shows an example of the results of the detailed investigation and general investigation. As shown cross section #2 in Fig. 4 of the ultrasonic thickness test results, it is revealed that the thickness at the outer curve of the elbow tends to be thinner than the normal thickness and thicker than both at the inner curve. By the test results of 3DME, it is revealed further that there exists distinct difference in thickness between the outer curve and inner curve of the elbow seems to have been formed by bending of the pipe with cold working. Besides, the profile of thickness deviation of an elbow shows much more clearly by 3DME which has higher resolution of 0.1 mm in pitch compare to the unclear results by ultrasonic thickness measurement of 100 mm in pitch.

Based on the information obtained, an observation result on the inner surface of the outer curve of an elbow is shown in the same figure. The observation result confirms that a lot of groove-like recesses and projections, like wrinkles, made by cold work exist on the inner surface of an elbow in a vertical direction of the flow.

Furthermore, by measuring the profile of thickness deviation of the cross sections #2, #13 and #16 in the same manner, it is confirmed that there exists distinct deviation of the thickness that the thickness at the outer curve of the elbow tends to be thinner than the one at the inner curve and it disappears in the straight portion of the pipe like cross section #16.

In addition, it is confirmed the facts that there is no wrinkle like structure observed on the inner surface like G in the cross section #13, where the effect of the cold working for pipe bending is

negligible, and that the inner corrosive surface appears to be covered by flat and substantially uniform general corrosion.

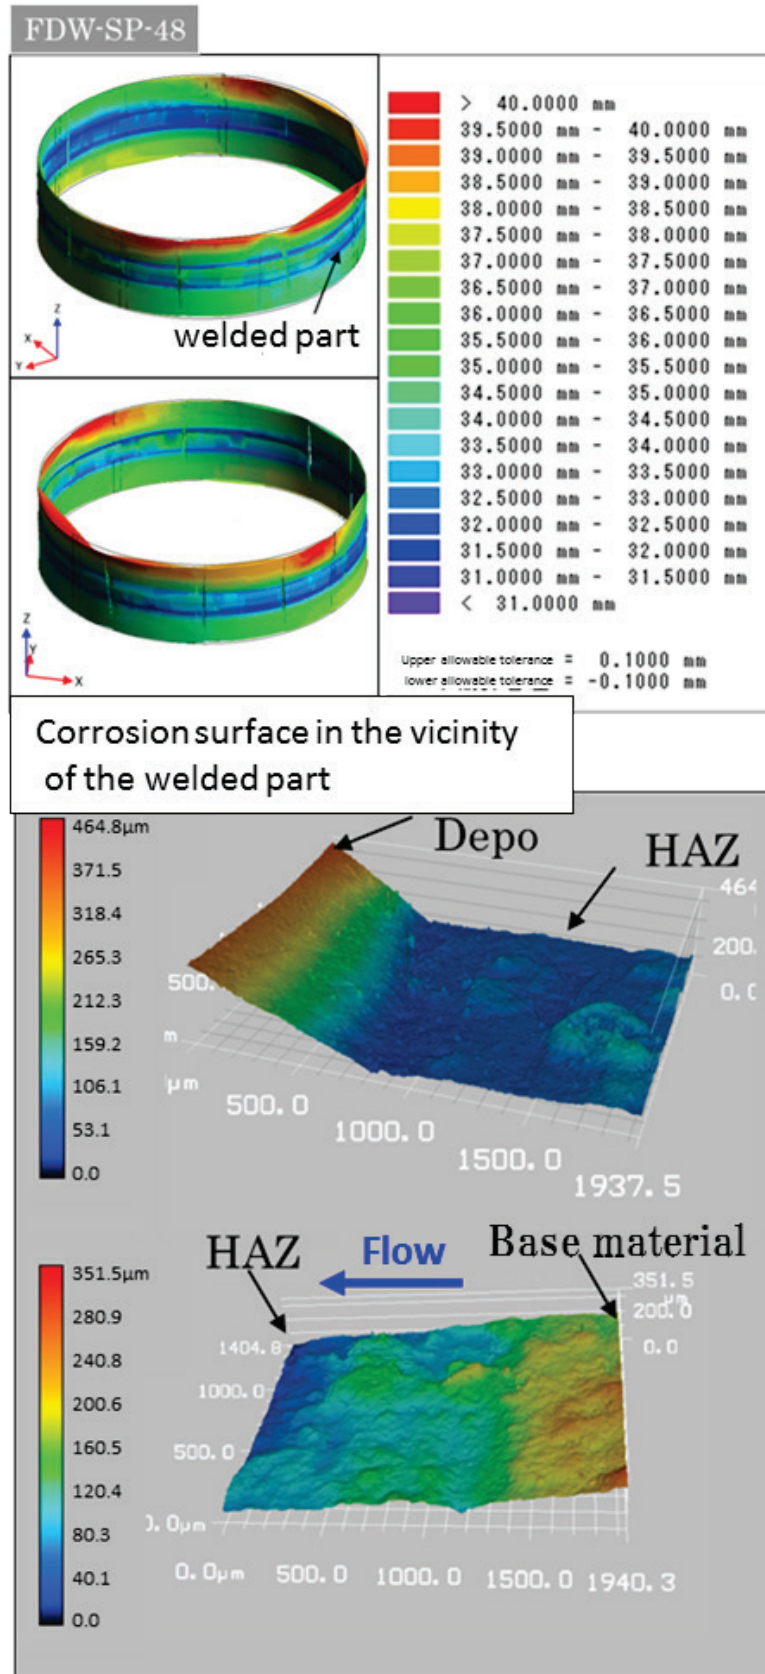
Fig.5 Results of the precise measurement at welded area using three dimensional wall thickness measuring device

Fig. 5 shows the results of the detailed investigation on the welded area in the same manner. It is shown that there exists thinner area along with the welding line in a radial direction corresponding to the heat affected zone (HAZ). Although it is confirmed again by the LASER microscopy the existence of the thinner area along with the weld line, no local corrosion has been confirmed. It is assumed that the thinner area along with the weld line was formed by the thermal shrinkage caused by welding heat input.

It is presumed that the significant deviation of the thinning rates near weld shown at the first periodic inspection was due to this thickness deviation and the use of nominal thickness for the thinning rate calculation instead of the last measured thickness, and that the thinning rate became the average at the second periodic inspection and after because of the use of the last measured thickness. Besides, it can be assumed that significant deviation of the thinning rates was caused by slight positional displacement at the measurement point where the thickness alters sharply at each measurement. There is a high probability that localized deformation and steep thickness change caused by cold bending, welding and other processes can affect the deviation of the thinning rates. Those facts were observed at the all detailed measurement targets.

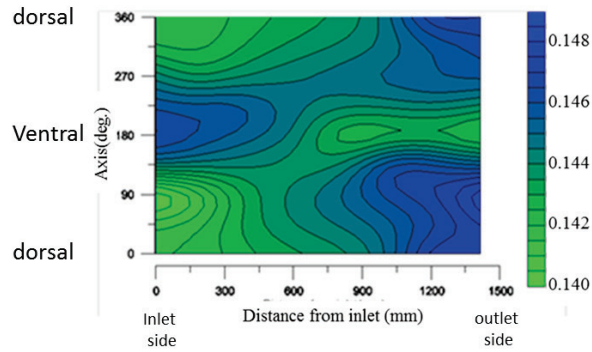
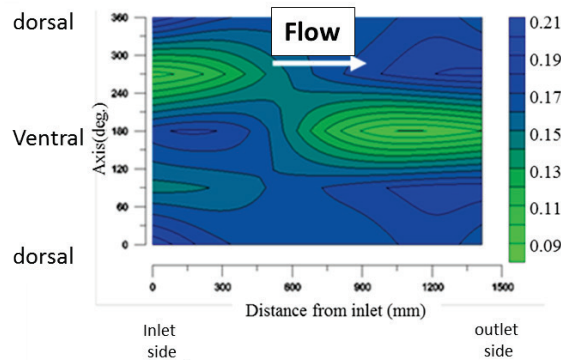
**Fig.8 Comparison of calculated wall thinning rate distributions with measured**

It is confirmed that there is a certain degree of correlation between flow energy distribution and thinning rate distribution, and the estimated value by DRAWTHREE-FAC is comparable to measured data.

However, there still exists significant difference in the thinning rate between measured and calculated up to two-digit.

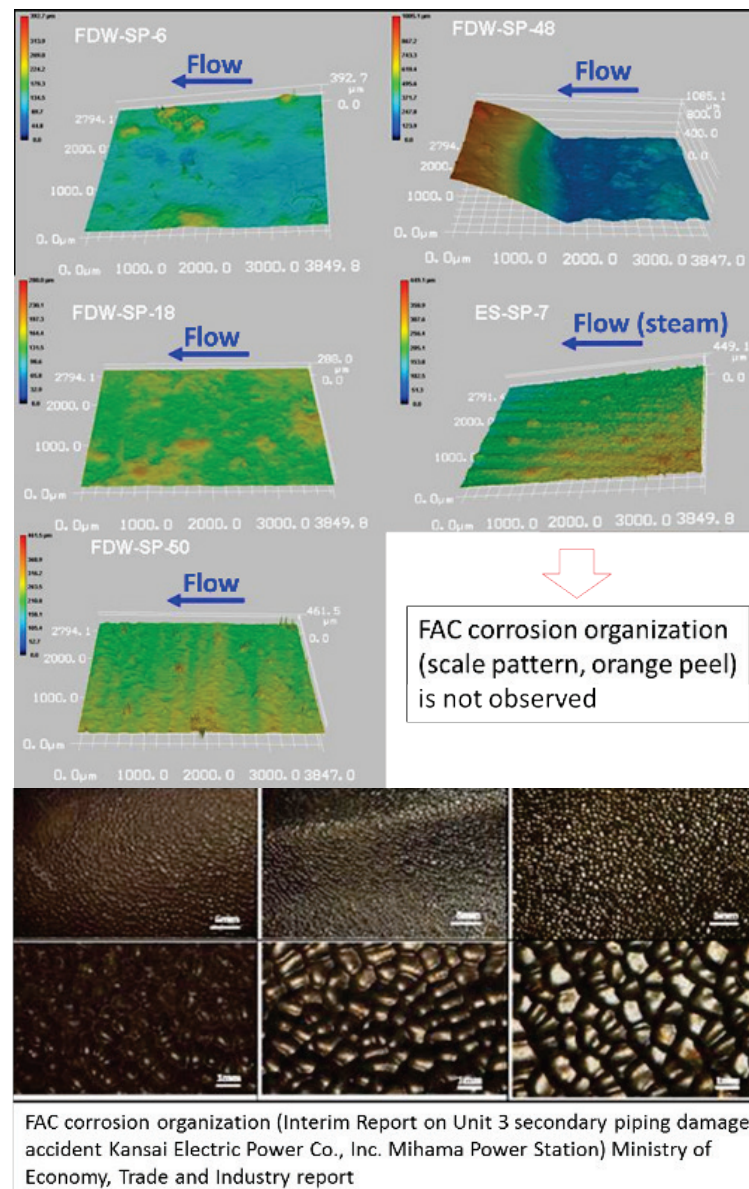
Fig.9 Comparison of corrosion surface observations and typical FAC surface

Fig.9 is a summary of the observation results of the corrosive surface of the detailed measurement targets. FAC corrosion organization known as orange peel and Scale patterns were not observed. There has been no corrosive surface of FAC such as scale-like or orange peer like structure observed on the corrosive surface of entire detailed measurement targets. Local corrosion also has not been observed, only uniform and general corrosion was observed. Typical examples of the corrosion surface of FAC reported by Ministry of Economy Trade and Industry [5] are shown for reference.

In addition, these observation results coincide with the fact that the total mean value of the thinning rates of entire 148 measurement targets, namely, about 28,000 measurement points investigated shows less than 0.1 mm per 10,000 hour, and This fact means that the management of the wall thinning at Fugen was appropriate.
