Characterization of the Corroded Surface Morphology of a Carbon Steel Piping Elbow Affected by Flow-Accelerated Corrosion

Hiroshi ABE^{1*}, Yutaka WATANABE¹, Makoto NAKASHIMA², and Tadashi TATSUKI²

² Research and Development Center, Tohoku Electric Power, 7-2-1, Nakayama, Aoba, Sendai, Miyagi, 981-0952, Japan

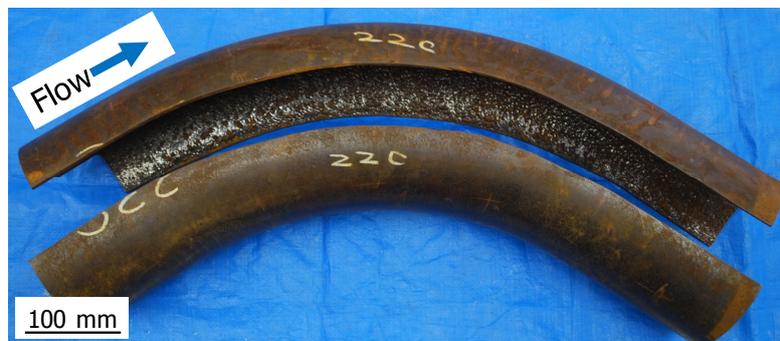
A 90-degree elbow component of an ascending pipe in an evaporator (deaerator) taken from a fossil power plant in Japan was used. The appearance of the sample is shown in Fig. 1. The inner surface shows a partly brown appearance on a black substrate due to surface oxidation and corrosion during long term storage in air. The surface has a shiny black appearance just after being removed. The outer diameter, the nominal piping wall thickness, and the radius of curvature are 140 mm, 6.6 mm, and 420 mm, respectively. The steel grade is carbon steel pipes for high temperature service (STPT410-S in JIS G 3456). The chemical composition of the sample and the history of the operating conditions for the region of interest are summarized in Tables 1 and 2, respectively. The phase state

Fig. 1. Appearance of the 90-degree elbow piping

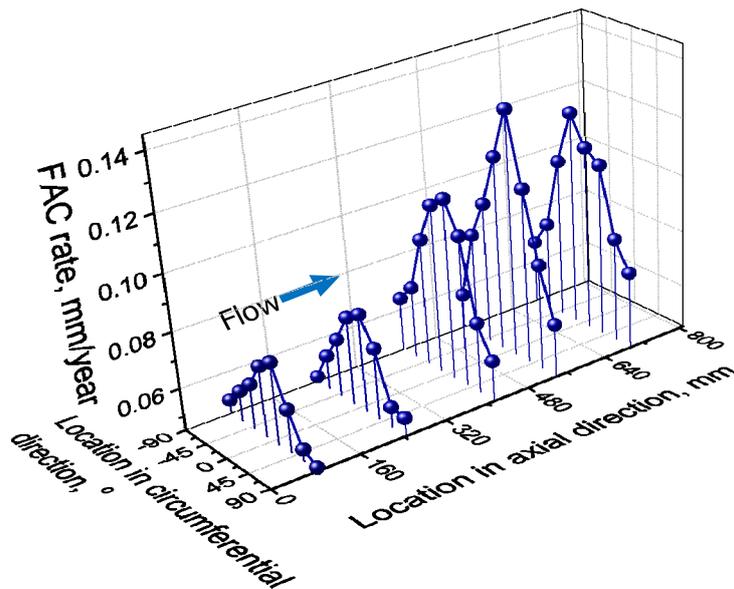
The local FAC rate profile on the extrados side of the elbow piping is shown in Fig. 2. For the location in axial direction, 0 mm and 800 mm correspond in position to 0-degree and 90-degree of the elbow, respectively. For the circumferential direction, a significantly higher FAC rate was observed at the center part of the extrados (0-degree). The FAC rate decreased linearly with distance from the

Fig. 2. Local FAC rate profile on the extrados side of elbow piping

center of the extrados to the intrados side. The difference in the local FAC rate was caused by the difference in the hydrodynamic parameter, and was not due to the material or water chemistry. These local FAC rate profiles should correspond closely to the local turbulence level affected by the piping geometry. For example, it was clearly demonstrated that the actual FAC rate and estimated mass transfer coefficient showed a maximum on the intrados for the short-radius bend; in contrast, the maximum of the above parameters were observed on the extrados for the long-radius bend [13]. Additionally, local hydrodynamic conditions should be considerably complicated because of the two-phase flow. For the axial direction, the FAC rate gradually increased with distance from the inlet, and it reached the peak value in the downstream side, beyond which it continued to decrease slightly. This tendency also suggested the development of local turbulence from the upstream to the downstream side in the elbow piping.

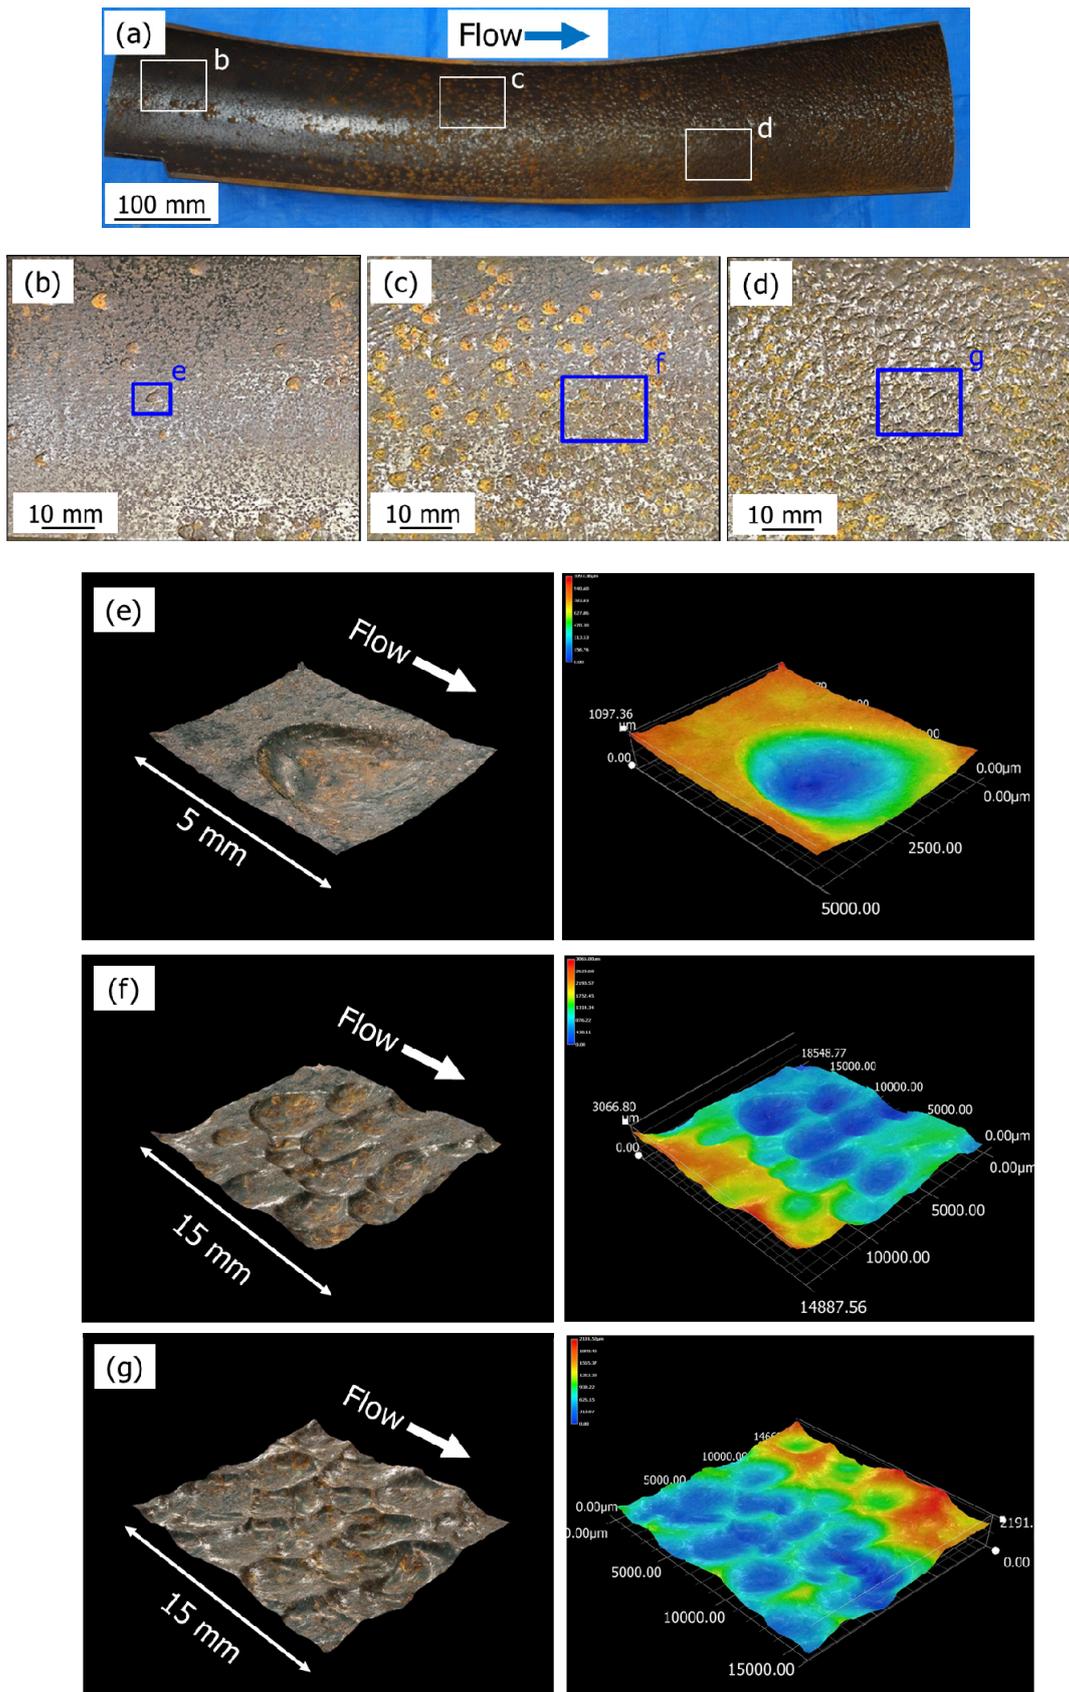
The transition in the morphology in terms of surface roughness on the extrados piping is summarized in Fig. 3. A relatively smooth surface with a sparse distribution of horse-shoe pits was observed on the upstream side, and the density of the pits gradually increased toward the downstream side (Fig. 3 (b) and (c)). Overlapping of the pits was observed near the middle parts of the elbow, and on the downstream side, the entire surface was found to be covered with a fine scalloped pattern. No tiger striping pattern was observed. As mentioned above, the scallop pattern and horse-shoe pit are widely recognized as typical morphologies for corroded surfaces affected by significant FAC in a single-phase flow. The finding indicates that the extrados side of the pipe wall was covered with a continuous liquid film (single-phase) like a “water slide”. The result shows the possibility of the occurrence of FAC by a single-phase flow in the area where there is a sudden change in flow regime, even when the nominal phase state of the fluid is a two-phase flow regime. As shown here, characterization of the inner surface morphology can occasionally give important information to estimate the local flow regime. Fig. 3 also clearly indicates that the occurrence of overlapping horse-shoe shaped pits gives a scalloped appearance [14]. Although the detailed mechanism for the formation of horse-shoe pits is still unclear, our results have revealed that the inner surface shape of piping affected by FAC is considered to essentially depend on the number density of nucleation sites for pit formation.

Fig. 3. Transition in the morphology in terms of surface roughness on the extrados piping. (a): Overall appearance of the inner surface of the extrados side, (b)-(d): Enlarged figures of the white squares in (a), (e)-(g): Enlarged 3D figures of the blue squares in (b)-(d), the left and right indicate color map and height contour map, respectively.

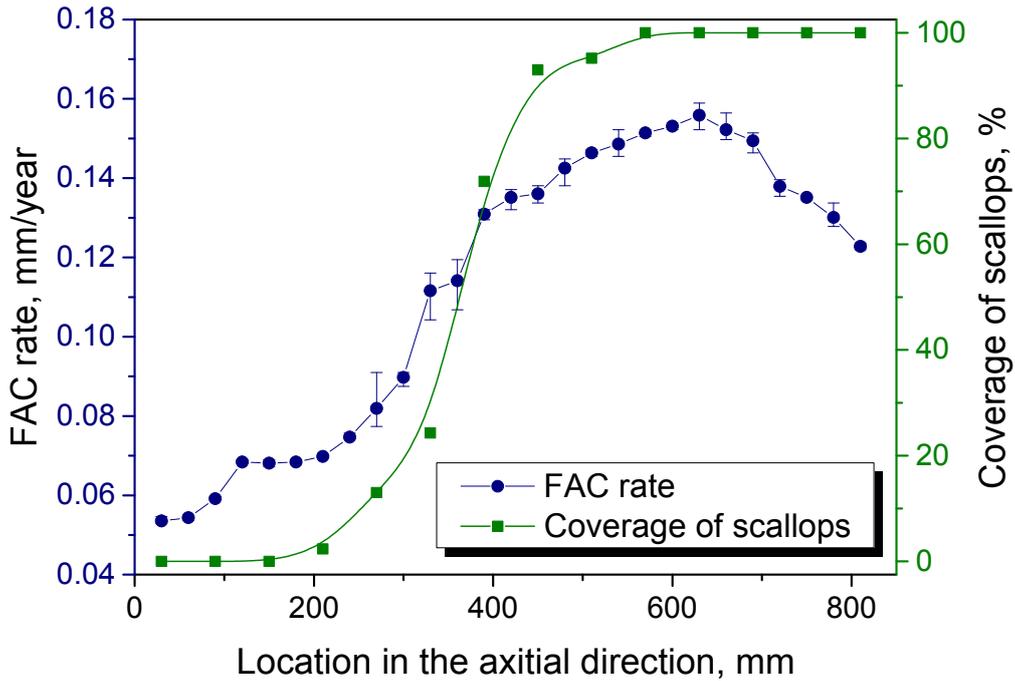
The profiles of the local FAC rate and coverage of the scallops along the center of the extrados in the axial direction with each 30 mm distance are shown in Fig. 4. The general FAC rate profile has already been explained in Fig. 2. The coverage of scallops increased from 0% (upstream) to 100% (downstream). Both the local FAC rate and coverage of scallops increase steeply in the region 300 to 400 mm away from the inlet of the elbow. Since there was a good correlation between the two, it seems that a significant acceleration in the FAC rate is possible due to scalloped surface formation. However, the local FAC rate and scallop coverage did not show a one-to-one relationship because there was a significant decrease in FAC rate observed in the downstream side; in contrast, the coverage of scallops was still maintained at 100%. The authors have already reported in another work that there was no significant increase in the FAC rate as a result of scallop formation although the local turbulence should increase by a hydrodynamic effect due to the formation of a scallop surface [12].

Fig. 4. Profiles of the local FAC rate and scallop coverage along the center of the extrados in the axial direction

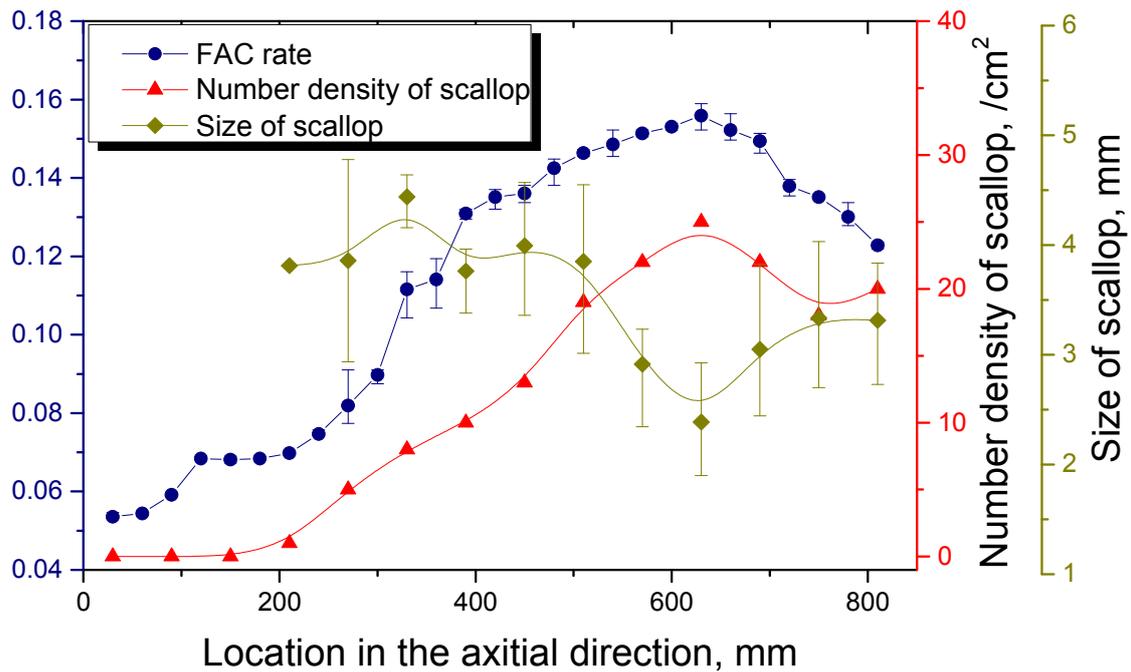
The profiles of the local FAC rate, number density, and size of the scallop are also shown in Fig. 5. The profile of the number density of scallops closely corresponded to the FAC rate profile. Both gradually increased with distance from the inlet, reached a peak at the same location, and then gradually decreased. The maximum size of the scallop (horse-shoe pit, in practice) shown in here was around 5 mm. The scallop size decreased with increasing FAC rate in the area most of which is covered with fine scallops. The inverse relationship between the FAC rate and scallop size corresponds to that observed in other findings, including examples from an actual power plant [15]. Fig. 5 also indicates that the FAC rate essentially corresponds to the number density of nucleation sites for pit formation, as mentioned above.

Fig. 5. Profiles of the local FAC rate, number density and size of scallop
