## Evaluation of Wall Thinning of the Steel Piping after Long Term Operation at Fugen Power Station

### ABSTRACT

Wall thinning of serviced carbon steel piping of the secondary cooling system after long term operation of Advanced Thermal prototype Reactor (ATR) Fugen power station has been investigated as a series of evaluation of validity and availability of utilization of serviced materials on research projects focused on aging management.

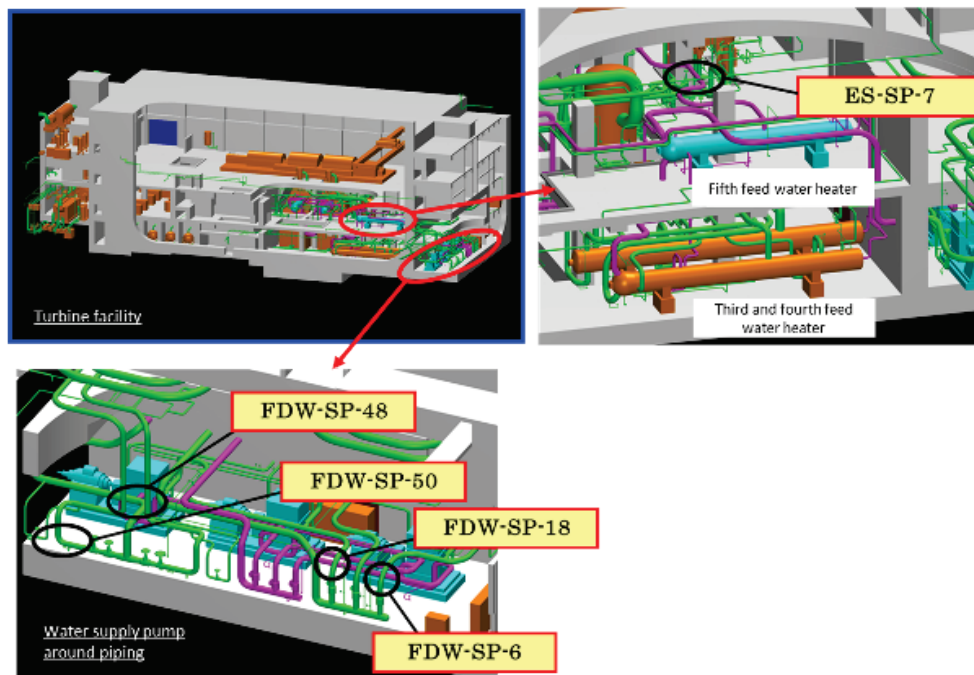
**Fig.3 The view of the measurement targets detailed investigation carried out.**

- ① Corrosion rate: The target must be located in the control area of FAC and LDI and having comparatively rapid or widely varying corrosion rates.
- ② Heat flow condition: Comparison between vapor-liquid two phase flow and single phase flow, and comparison of the measurement points having different corrosion rates under the same heat flow condition, can be carried out.
- ③ Unsteady parts such as type of materials and weld joint: Comparison between carbon steel and low alloyed steel, and comparison between unsteady parts such as weld joint and steady parts, can be carried out.

Thus, the measurement targets for the detailed investigation were chosen as shown in Fig. 3.

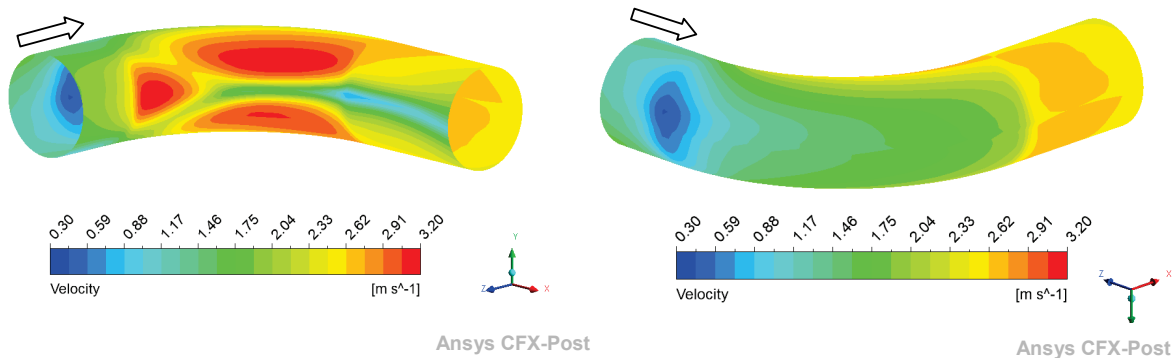
**Fig.6 The synthetic flow velocity distribution on the surface of a wall in the vicinity of FDW-SP-48 elbow**

Flow analyses have been carried out around the measurement targets for the detailed investigation mentioned above with the steady state condition of Fugen during operation using a commercial flow analysis code, Fluent of ANSYS. Three dimensional analysis was adopted, and in each flow analysis, the estimation area was expanded to the upstream elbow or bent of those targeted.

Fig. 6 shows an example of the results of the flow analysis on the welded area in the same manner.

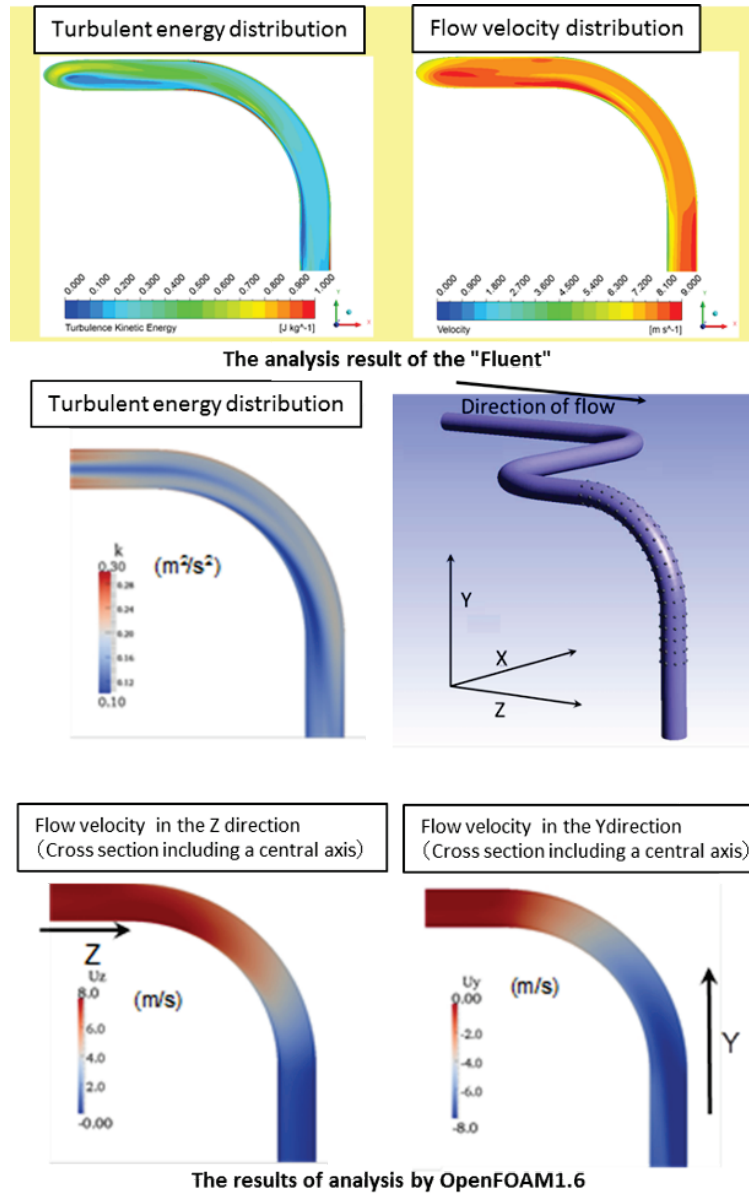
**Fig.7 Comparison of flow analysis results between Fluent and OpenFOAM in the vicinity of FDW-SP-6 elbow**

Comparing the estimation results obtained by Fluent with the results obtained by other commercial three dimensional flow analysis code, OpenFOAM [3], there are no significant differences in turbulent flow energy distribution and flow velocity distribution as shown in Fig. 7.
